Aviation Investigation Preliminary Report

Location:	Truckee, CA	Accident Number:	WPR24FA119
Date & Time:	March 30, 2024, 18:37 Local	Registration:	N960LP
Aircraft:	Daher TBM700	Injuries:	2 Fatal
Flight Conducted Under:	Part 91: General aviation - Personal

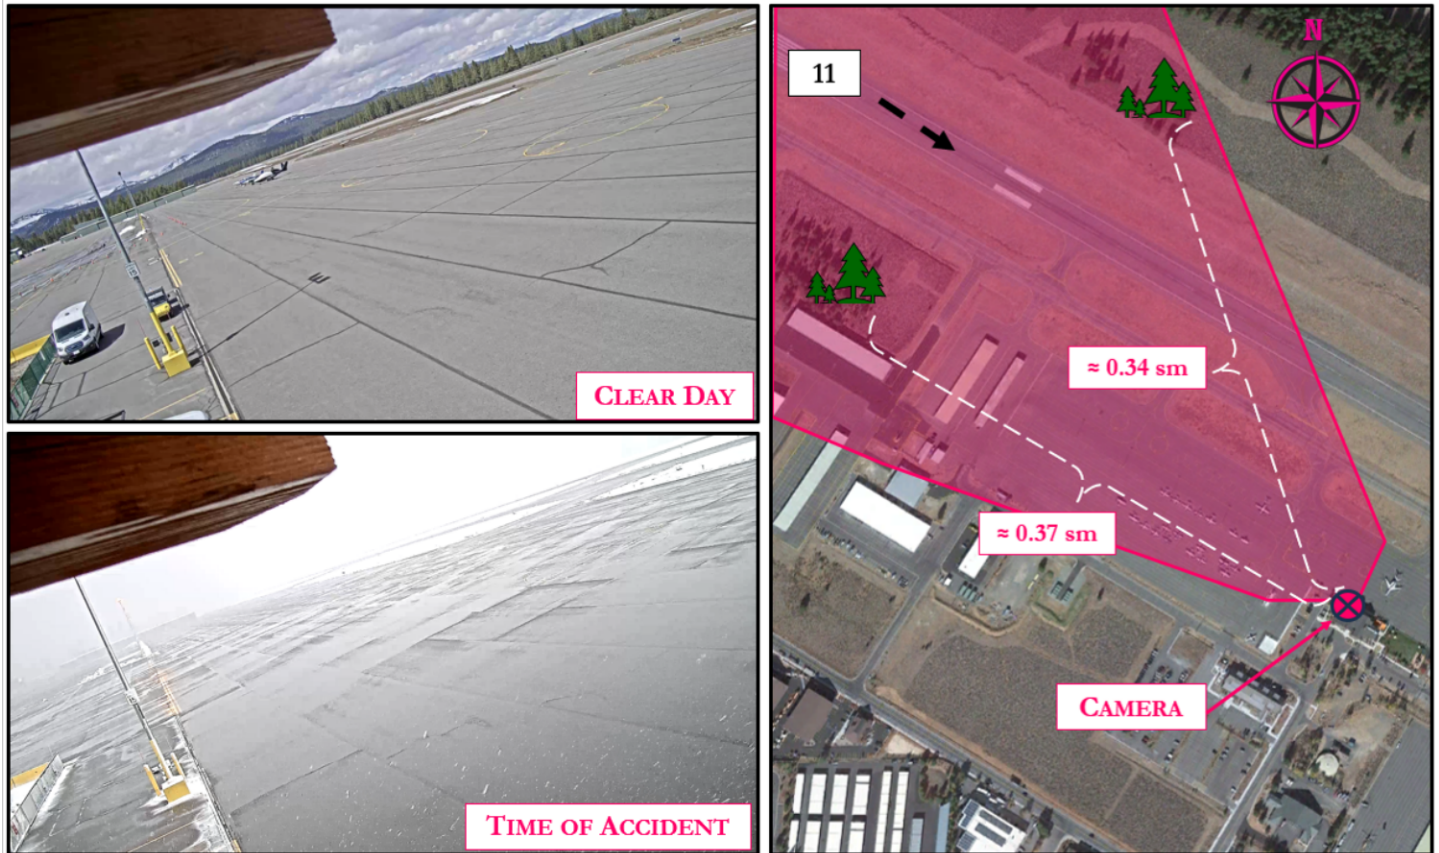
A routine aviation weather report (METAR) for TRK was issued about 2 minutes before the accident. It stated: wind calm, visibility 3/4 mile in light snow, ceiling overcast at 900 ft agl, temperature 30° Fahrenheit, dew point temperature 30° Fahrenheit, altimeter 29.66 inches of mercury (inHg). A review of video camera footage at the airport and near the accident site revealed that the visibility at the time of the accident was under 0.34 statute miles (see Figure 5 below).

Figure 5: Weather at the Airport
